**RACOLA TAILINGS DAM
WASHINGTON COUNTY, MISSOURI
MO 30475**

**PHASE 1 INSPECTION REPORT
NATIONAL DAM SAFETY PROGRAM**

RACOLA TAILINGS DAM
WASHINGTON COUNTY, MISSOURI

Name of Dam	Racola Tailings Dam
State Located	Missouri
County Located	Washington
Stream	Offstream from Old Mines Creek
Date of Inspection	15-16 April 1979

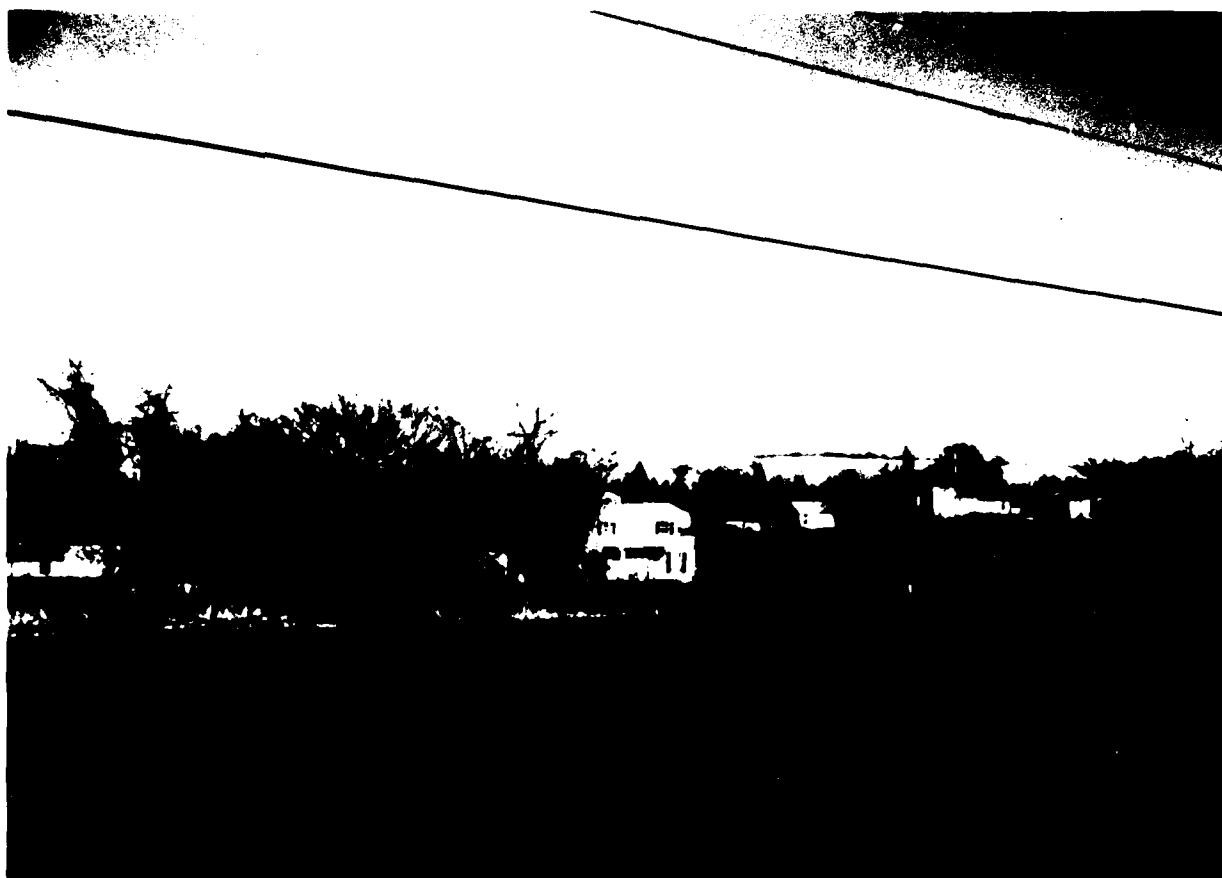
Overview of Racola Tailings Dam (30475)
from Rt. 21.

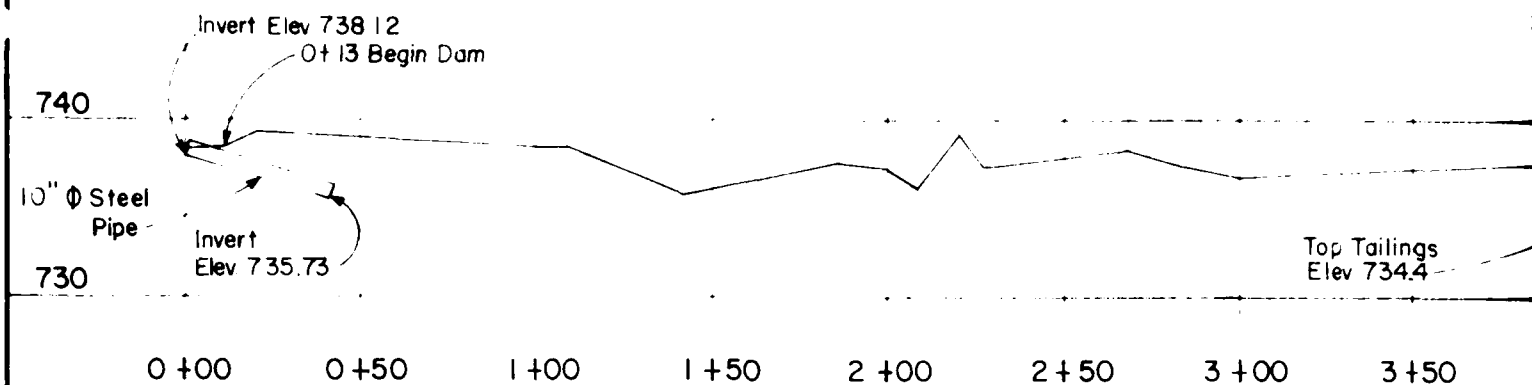
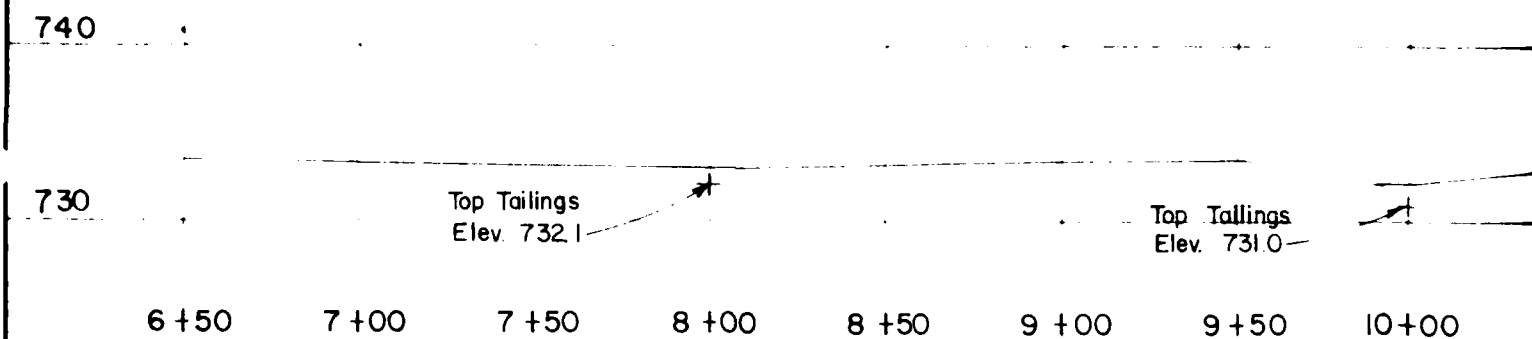
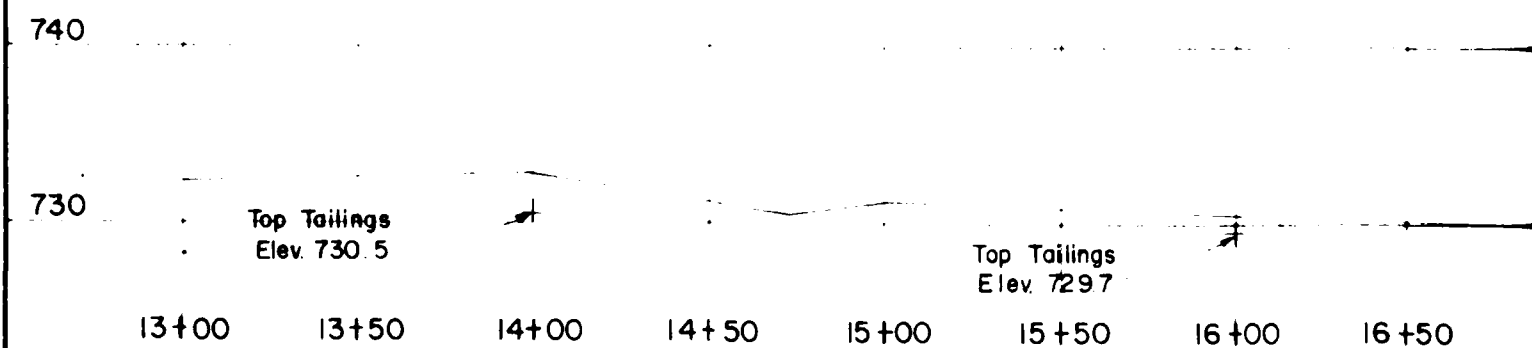
PLATE 4A

During the field inspection, active gravel mining activities on the crest were observed (see Plate 4). This has effectively reduced the crest elevation, and with it the reservoir's ability to effectively retain runoff.

Excavation of
Dam on
Right Side

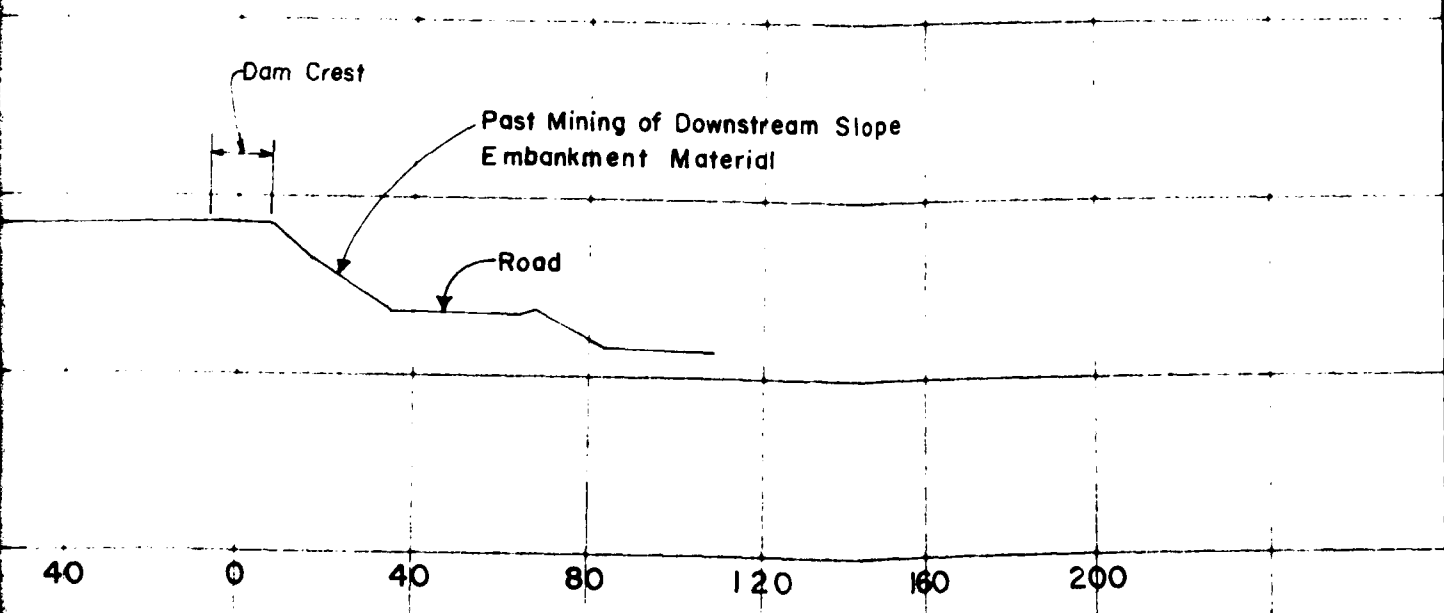
CROSS-SECTION AT STA. 6+00

No functional spillway was observed. The two outlet pipes located appear to be incapable of passing impounded water. The lack of a spillway increases the likelihood of overtopping. The downstream slopes near Stations 30+00 and 6+00 are excessively steep due to past mining of gravel from the embankment toe.

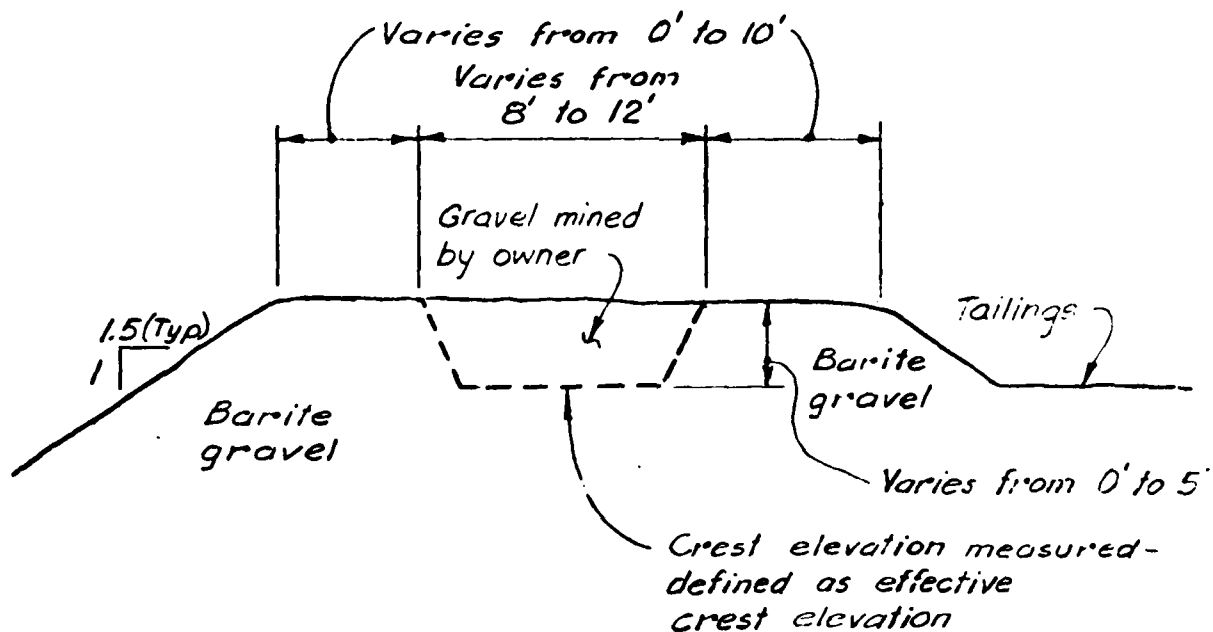
CREST DETAIL
 Typical where gravel is mined on dam crest

The inspection team observed that the present owner is actively mining gravel from the dam crest near the low point of the dam. This has the effect of reducing available freeboard and the dam's ability to retain runoff. This is a serious deficiency which should be corrected immediately.

A periodic inspection program should be initiated so that indications of instability, such as cracks in the dam, sloughing, sudden settlement, erosion of the dam, or an increase in the volume or turbidity of water from the springs or seeps, can be monitored. Maintenance of the dam is inadequate, and the practice of excavating gravels from the embankment should cease immediately.
